**SOUTHEAST AREA DRAINAGE
DISTRICT STUDY,
EAST PROVIDENCE, RHODE ISLAND**

March 1996

**US Army Corps
of Engineers**
New England Division

Plate 1 - Study Area

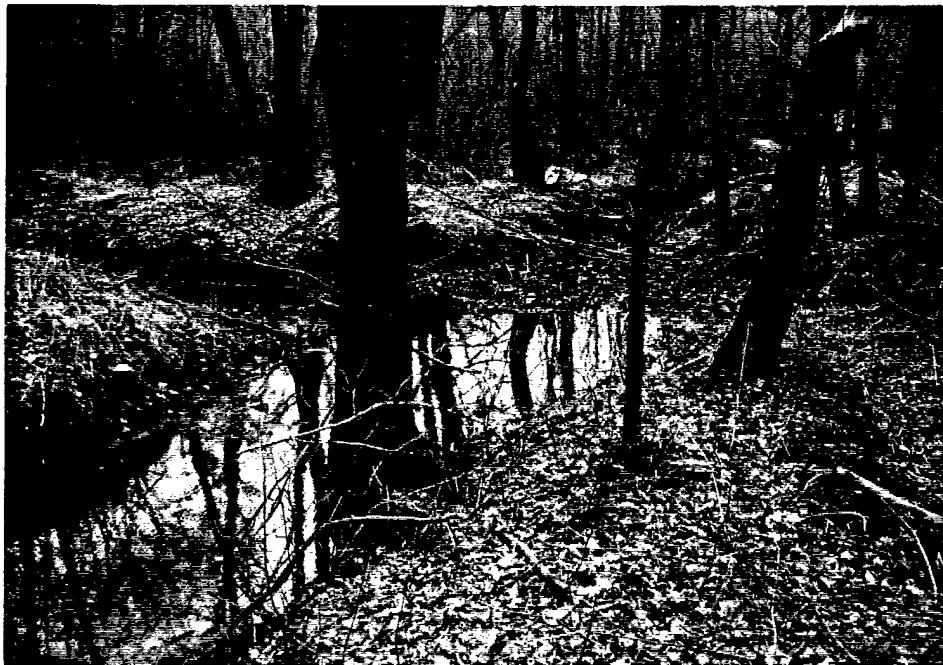
Photo 2 - Normal flow path turns to east in vicinity of Thurston Street. Secondary channel continues to the south.

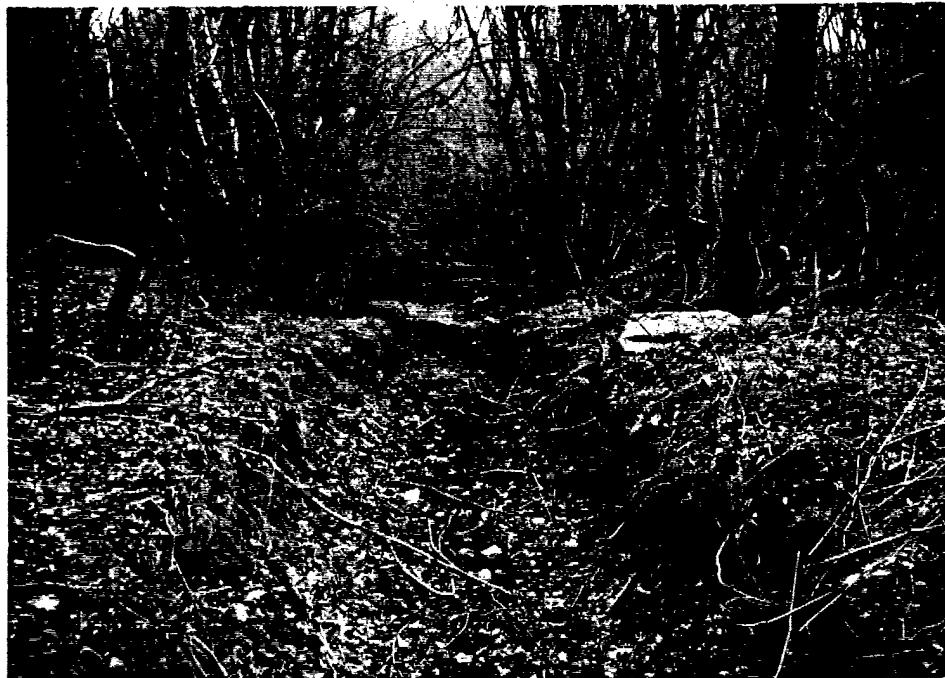
Photo 3 - Upstream of Rounds Ave. No flow in secondary channel.
Looking north from Rounds Avenue.

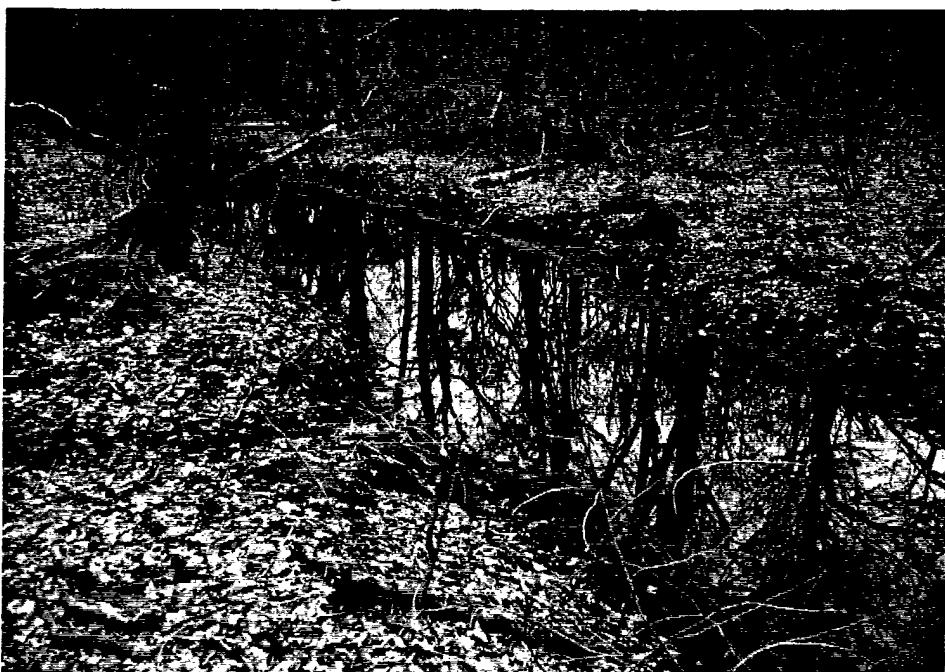
Photo 4 - Upstream of Rounds Ave. & Tanglewood Drive.
No flow in secondary channel, looking northeast.

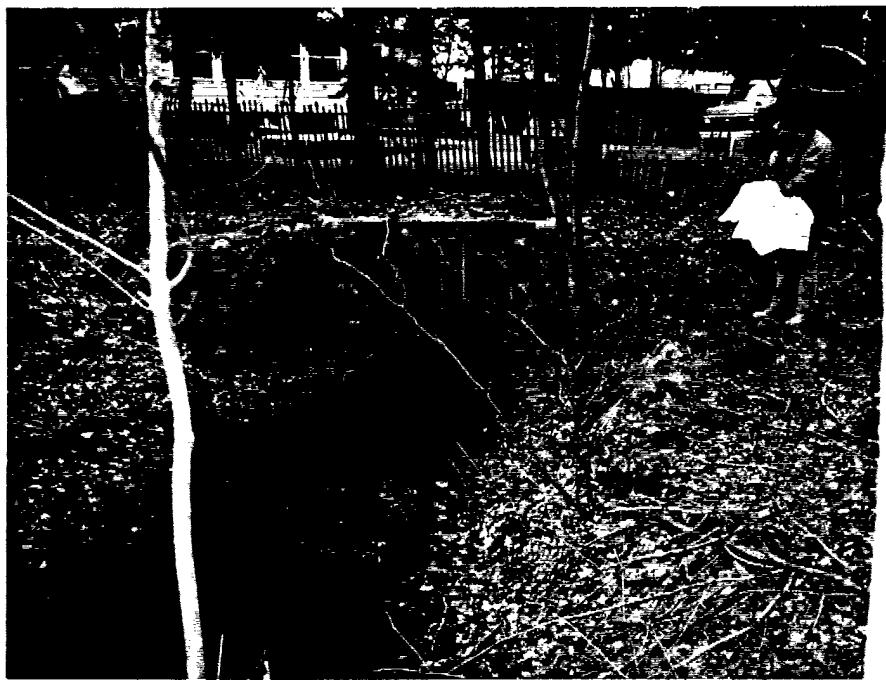
Photo 5 - Normal flow path enters 48" diameter pipe
@ Tanglewood Drive and Rounds Avenue.

Minor sediment buildup in pipe of about 1-2". Stone and mortar headwalls are in good condition with only some minor areas of missing mortar at the wingwall. A trash rack/grate is attached to the headwall. The pipes of the grate are corroded and bottom portions of the pipes are missing. (See Photo 5)

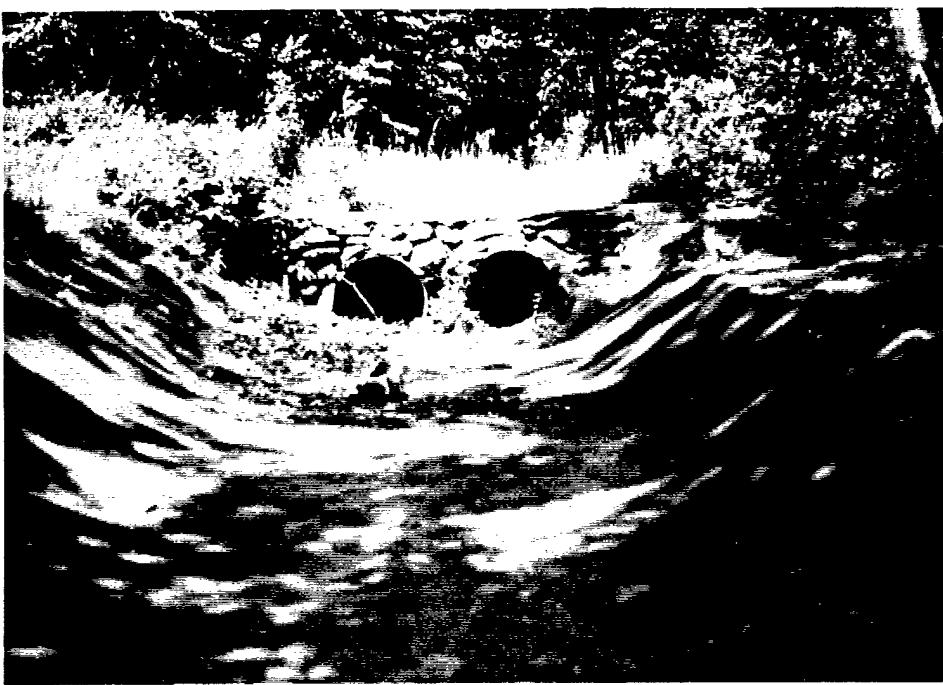
Photo 7 - Downstream end of culverts at Rounds Avenue.
Note channel is paved.

Downstream: Good channel alignment; channel invert and side slopes are paved with asphalt. Pavement appears to be in good condition. (See Photo 7) The asphalt lined channel continues for about 900' and ends south of Robin Hood Drive.

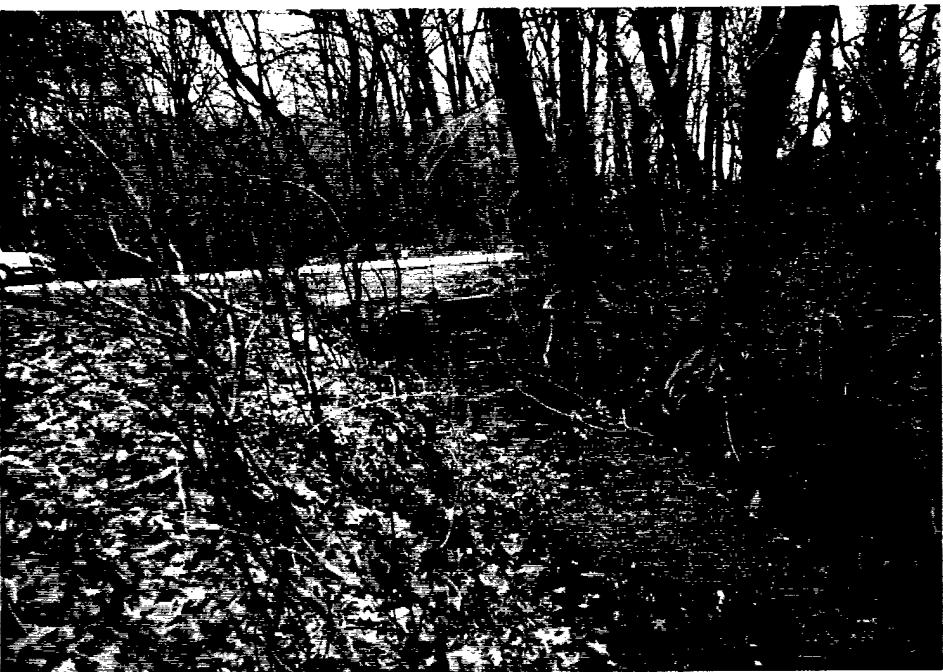
Photo 8 - Downstream of Glenrose Drive. 30" diameter pipe.

Stone/mortar headwall at upstream end has some loose stones and missing mortar. Concrete headwall at downstream end is in good condition. There are minor spalls and chipping of concrete pipe. There is no apparent settlement or deflection of the culvert. Approximately 70' downstream is the confluence of the main flow from Annawomscutt Brook which discharges from the drainage network. (See Photo 8)

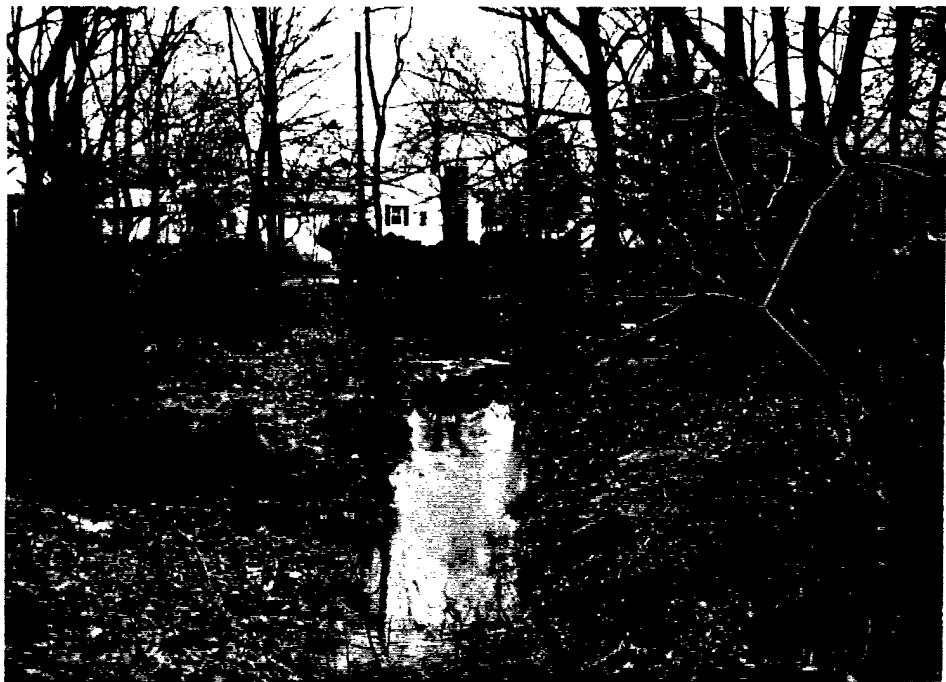
Photo 9 - Downstream of Glenrose Drive. Note two 36" diameter pipes is outfall for drainage network conveying normal flow path.
Secondary channel enters at the left.

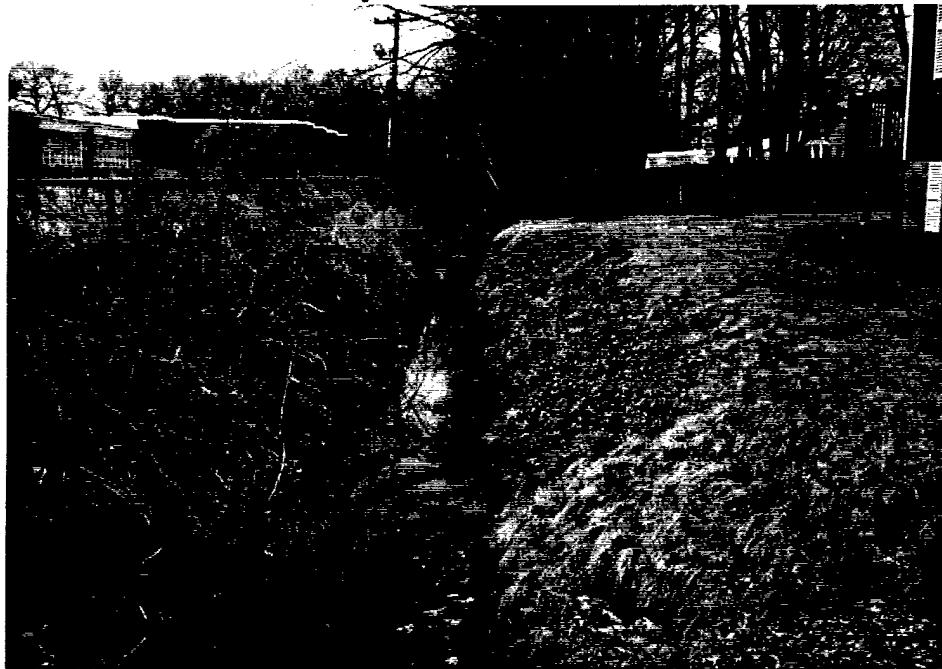
Photo 10 - Typical channel looking upstream (north) from Legion Way.

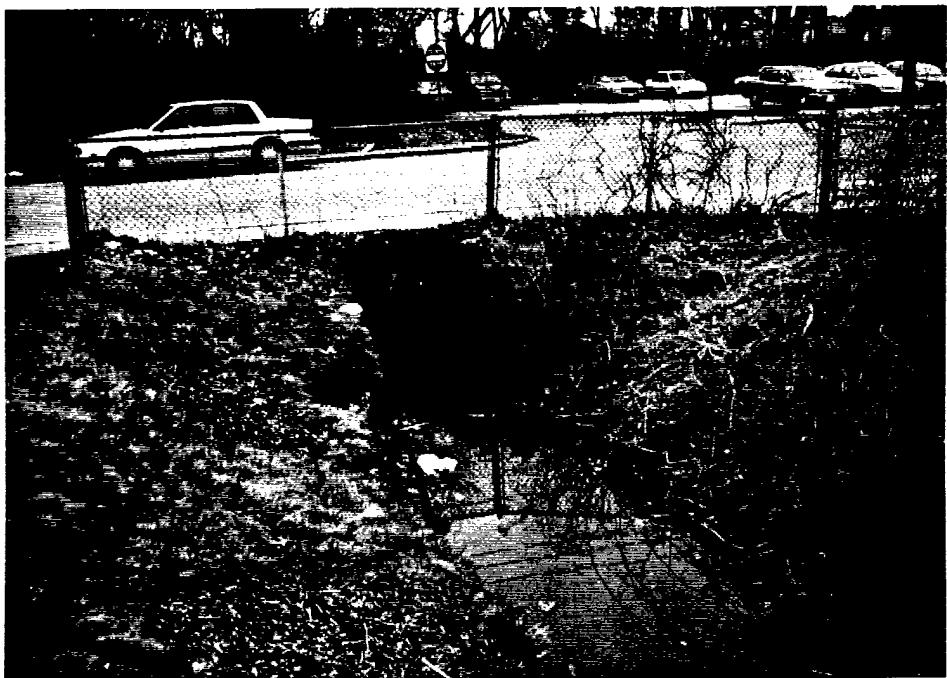
Photo 11 - Upstream @ Legion Way looking south.

Stone/mortar headwalls and wingwalls are in fair condition with some minor spalling and cracking of mortar. (See Photo 11) No visible settlement or deflection of walls, culvert, or roadway. Downstream outlet was not observed due to inaccessibility. There is also an 18" diameter pipe discharging to the brook from the west bank just upstream from the culvert inlet. It appears this pipe drains the adjacent school property.

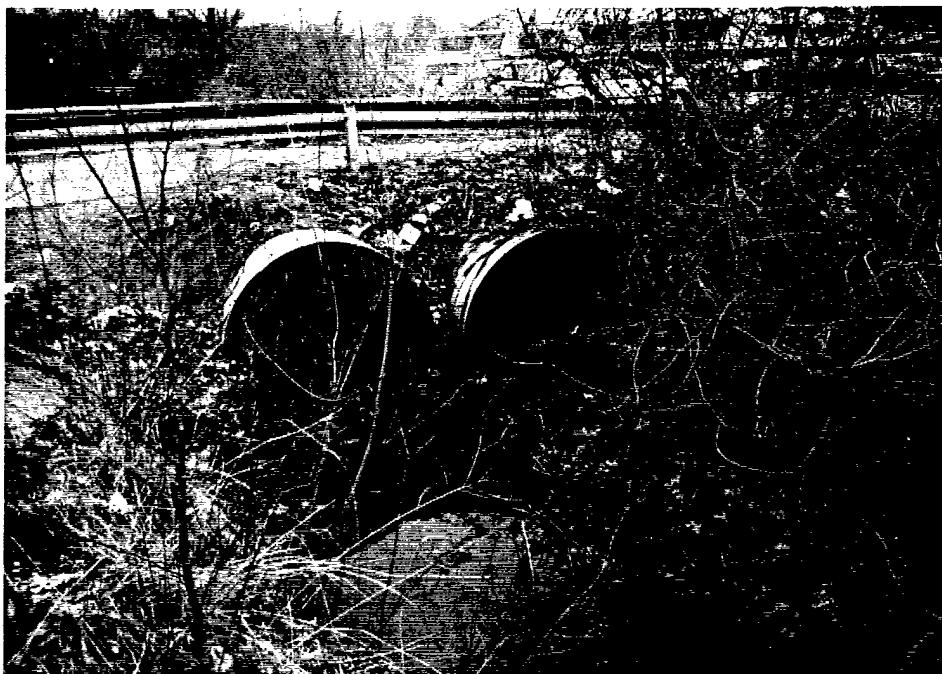
Photo 12 - Upstream end of north access road at plaza parking lot.

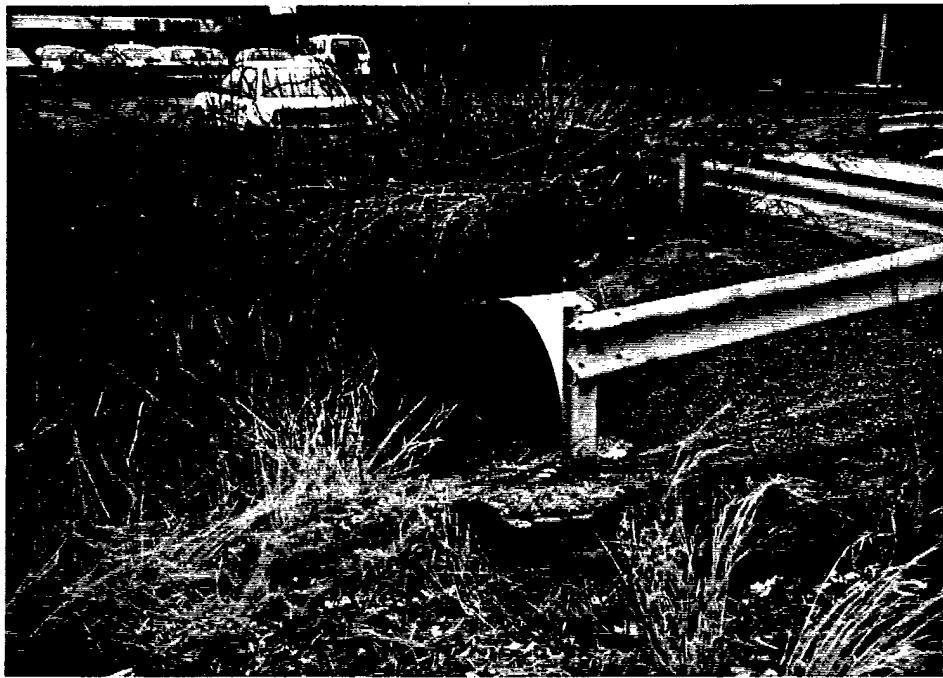
Photo 13 - Downstream end of north access road at plaza parking lot.

Downstream: Heavy sediment buildup and vegetation at outlet of west pipe, similar to upstream end. Erosion of the east downstream bank has occurred at the top with the loss of pavement material. However, this condition appears to be due to surface runoff from the parking lot rather than streamflow conditions during rain events. There is heavy vegetation along both banks. Heavy vegetation prevented obtaining invert elevation of west culvert pipe. (See Photo 13)

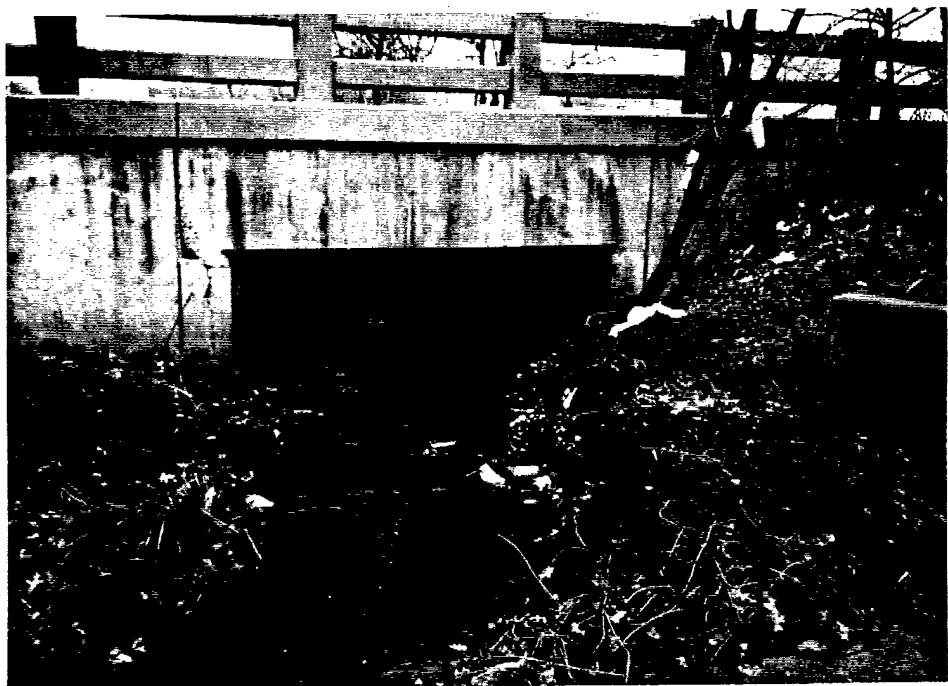
Photo 15 - Downstream @ Willett Avenue. Note headwall on right for 3.5' diameter drainage pipe.

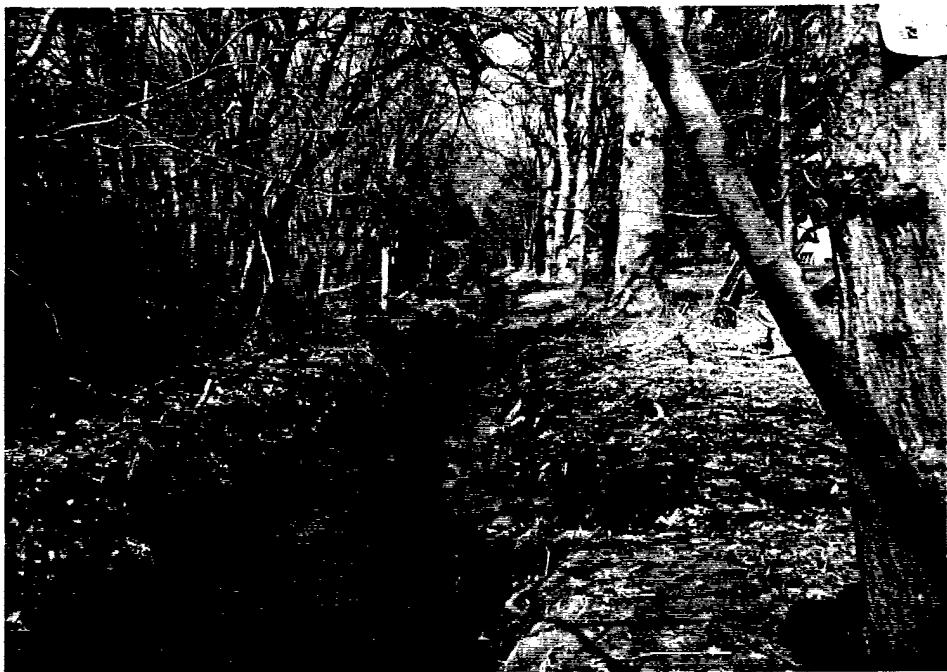
Photo 16 - Typical brook configuration. Looking upstream from Promenade Street.

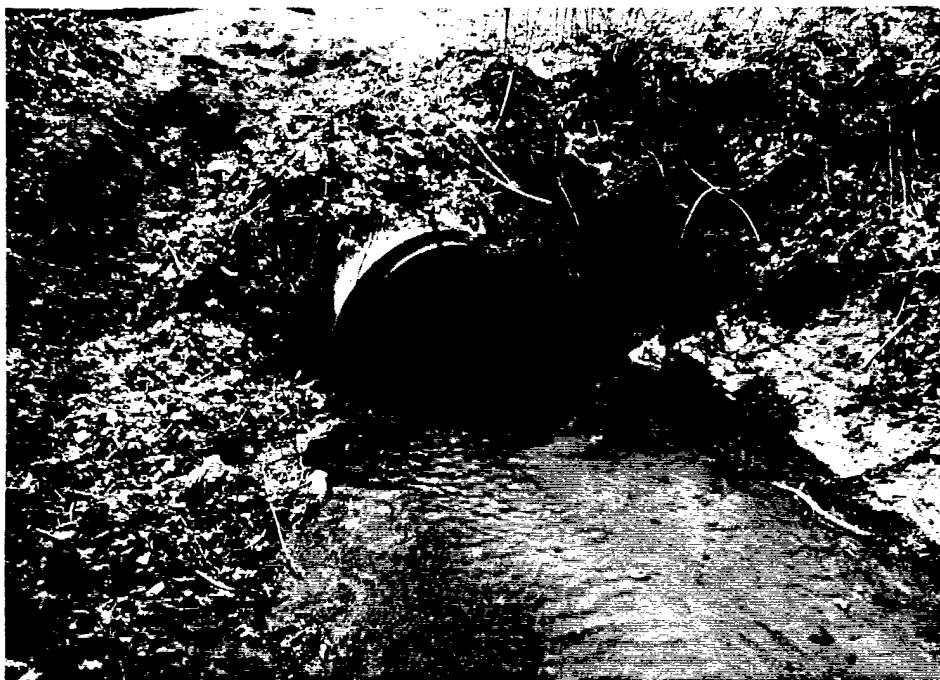
Photo 17 - Upstream end @ Promenade Street.

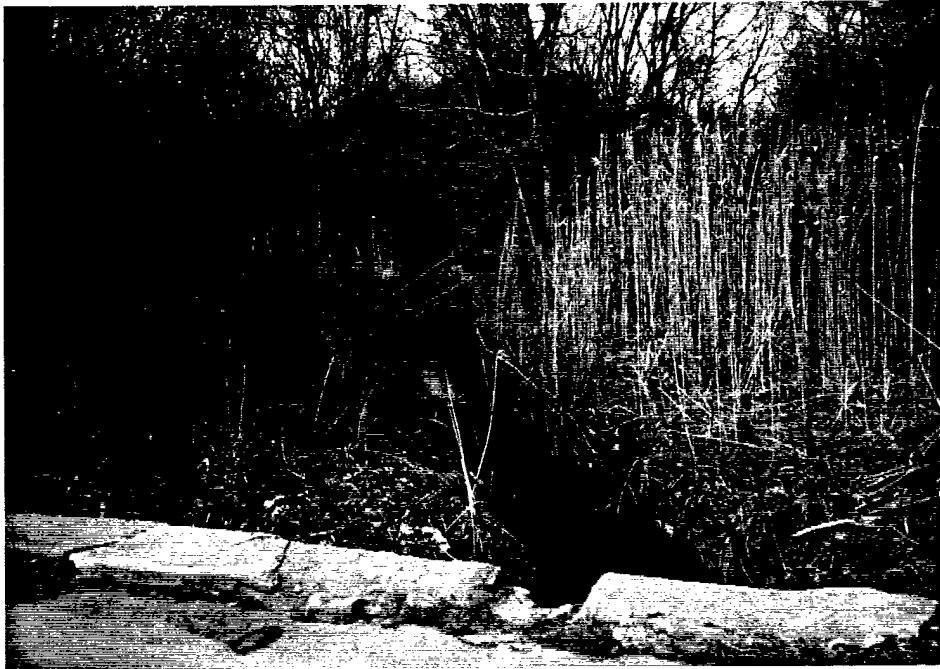
Photo 18 - Typical channel configuration. Looking upstream from Haines Park Road.

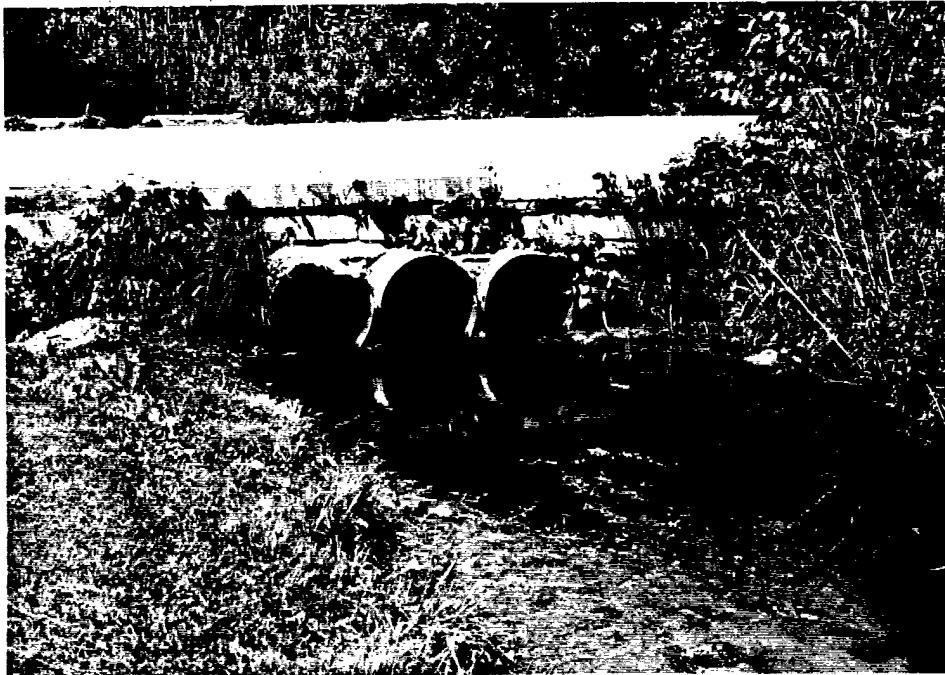
Photo 19 - Downstream end of Haines Park Road culverts.

No significant deterioration of pipe or deflection or settlement is apparent. Minor silt buildup (1-2") at upstream end of center culvert. (See Photo 19)

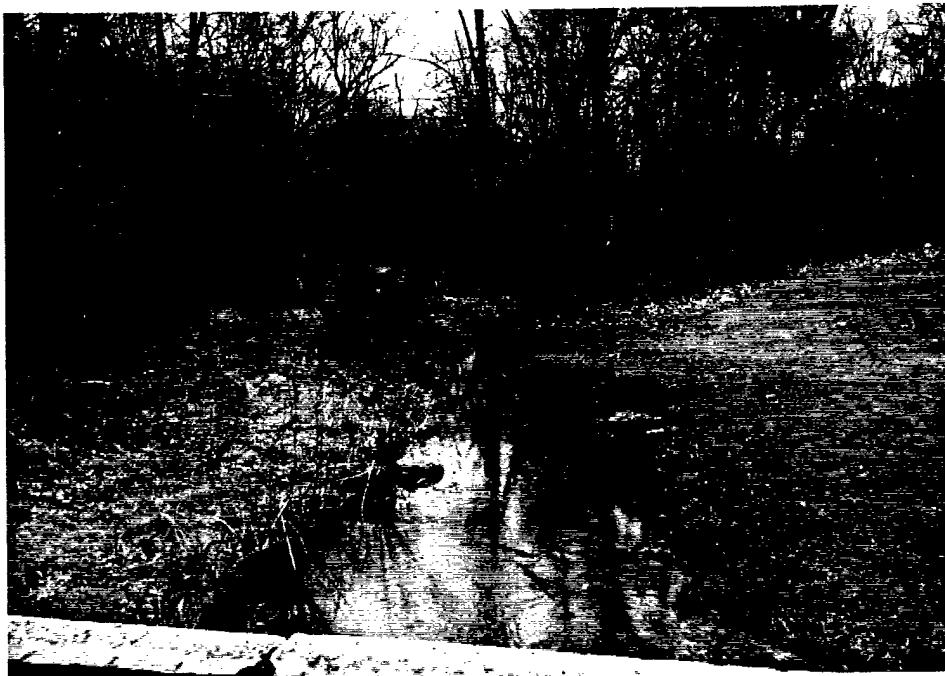
Photo 20 - Typical channel configuration. Looking downstream from Haines Park Road.

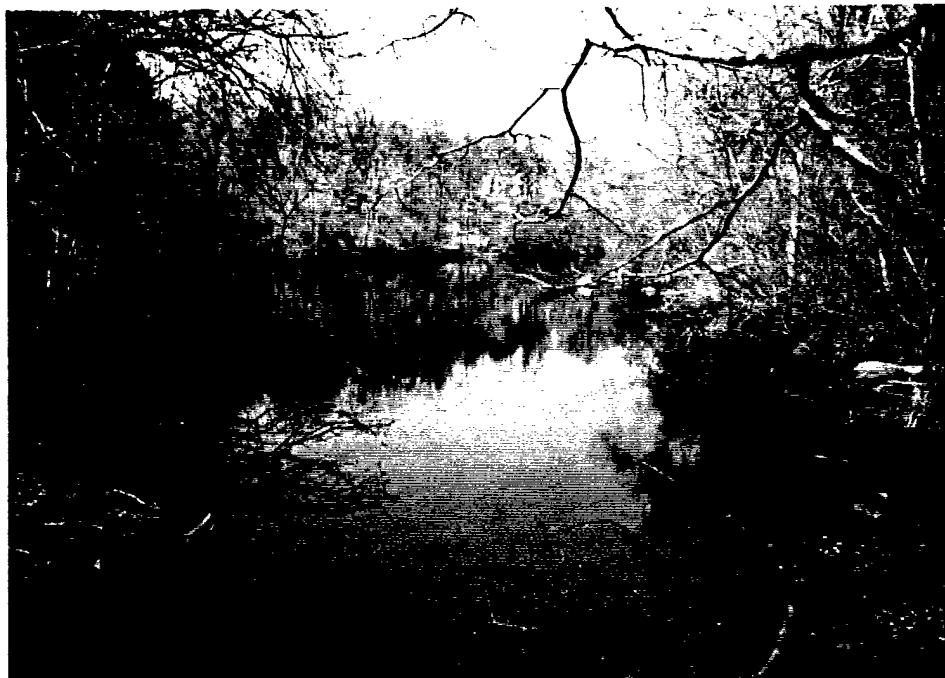
Photo 21 - Looking upstream north of bike path.

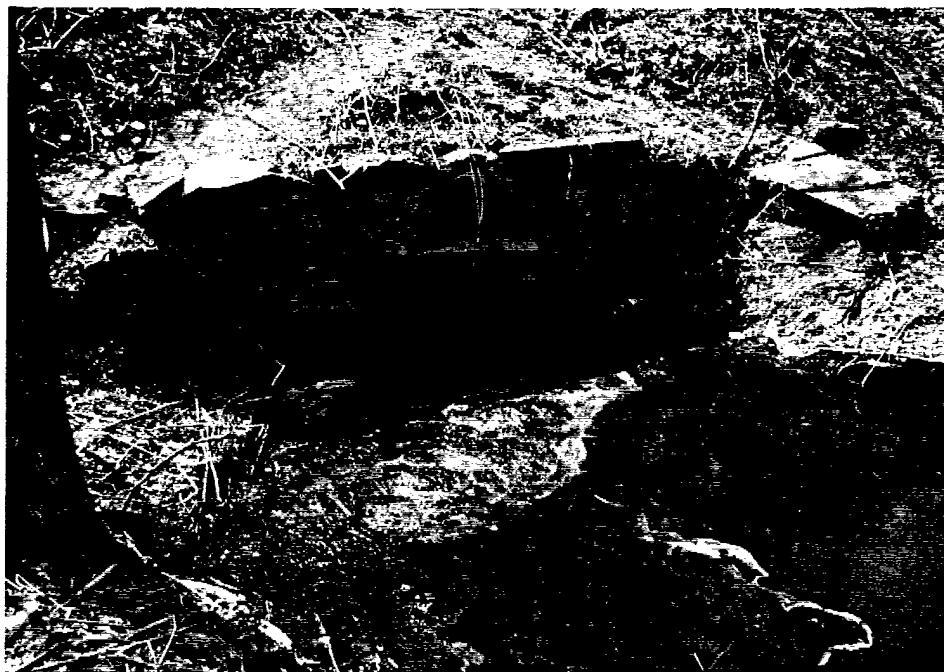
Photo 22 - Upstream end of stone culvert under bike path.

Culvert barrel was not visible. Headwalls are stone masonry in fair condition. (See Photo 22)

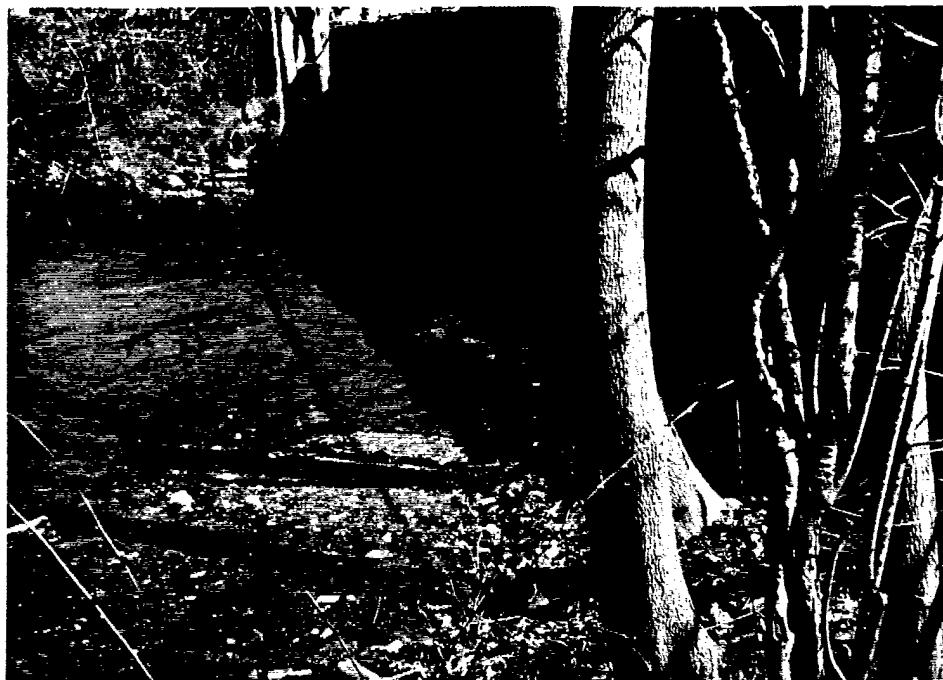
Photo 23 - Upstream at 60" diameter culvert
under Bay Spring Avenue.

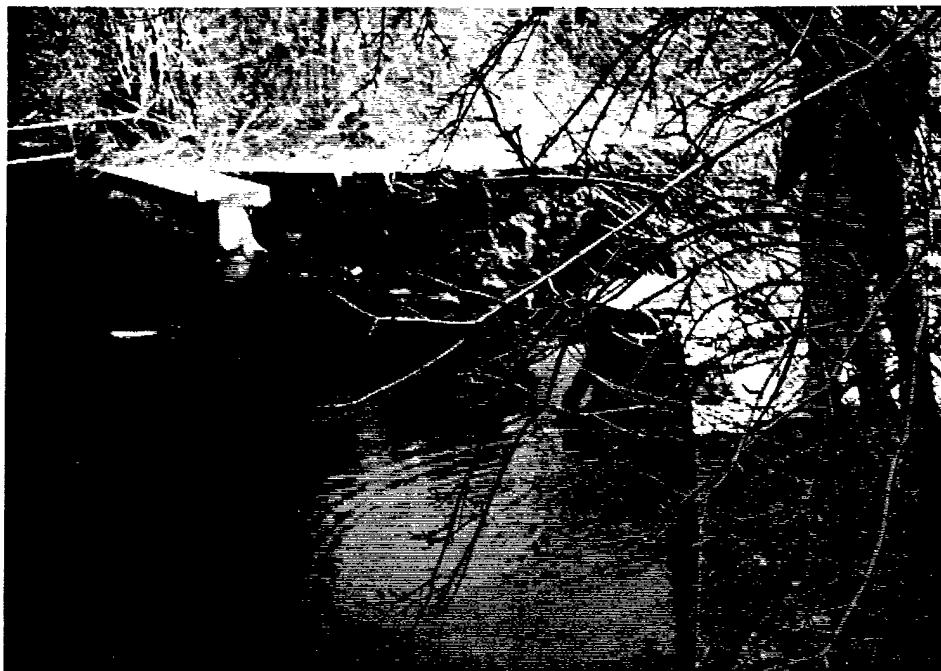
Photo 24 - Dam and weir structure at Drown Cove.
